(6) National Dam Inspection Program.  
LAKE HENRY DAM  
(NDI ID <sup>Number</sup> PA-00366  
DER ID <sup>Number</sup> 35-16),  
~~PENNSYLVANIA GAS AND WATER COMPANY~~  
Susquehanna River Basin, Lake Run,  
Lackawanna County, Pennsylvania.  
PHASE I INSPECTION REPORT

LAKE HENRY DAM

NDI ID No. PA-00366  
DER ID No. 35-16

PHASE I INSPECTION REPORT  
NATIONAL DAM INSPECTION PROGRAM

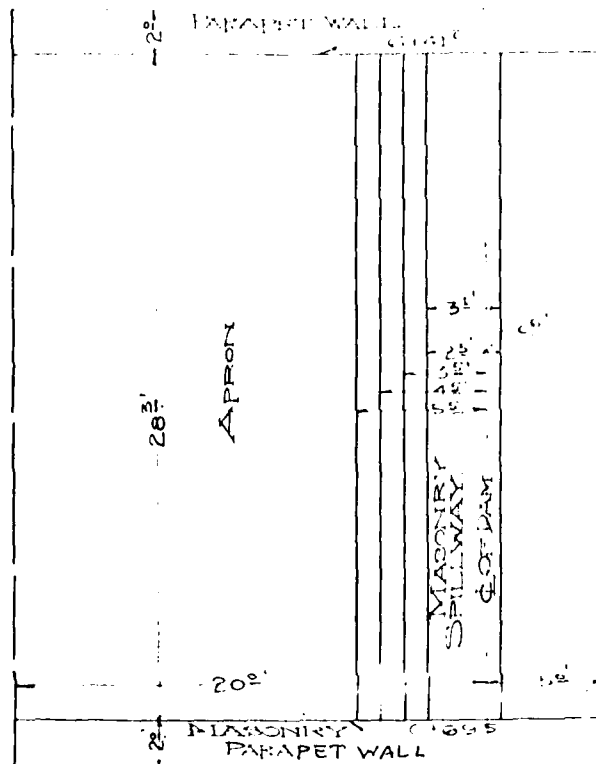
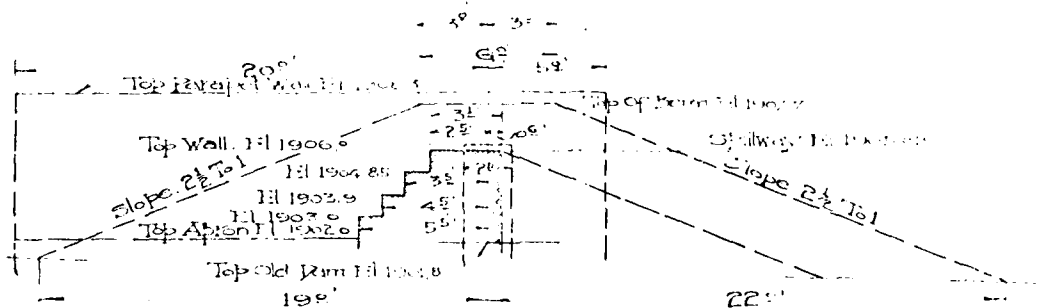
PLAN OF SPILLWAY  
Scale 1"=4'

The masonry spillway is in fair condition. The mortar in the spillway walls is somewhat deteriorated. Thick brush is growing in the spillway apron. The stumps remaining from brush cutting are pushing up the paving in areas of the apron.
